It Stalls at a Stop

by Tom Endy

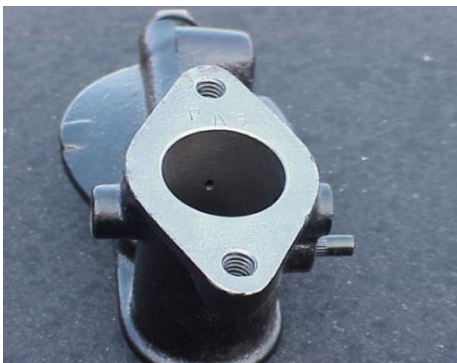
The small hole in the throat of the upper casting allows air to flow into the idle circuit when the throttle is closed.

The throttle plate must close such that half of the hole just peeks above the closed throttle plate.

It was then I began to think about the throttle plate itself. If the throttle plate does not close on the idle circuit hole in the throat properly it could adversely affect the flow of air to the idle circuit. The transfer from run to idle would then be disrupted.
